# Differential Stone Decay of the Spanish Tower Façade in Bizerte, Tunisia

K. Zoghalmi, Ph.D.<sup>1</sup>; P. Lopez-Arce, Ph.D.<sup>2</sup>; and A. Zornoza-Indart<sup>3</sup>

**Abstract:** The Spanish Fortress of Bizerte in Tunisia shows differential erosion patterns on the rock ashlars used in the construction of its main façade (sixteenth century) exposed to marine aerosol action and several restoration works. In order to determine the origin of this erosion and the degree of stone decay, a combination of microdestructive and nondestructive techniques have been used on-site and in the laboratory. Moisture measurements, ultrasonic velocity propagation, and water absorption by a Karsten pipe test, together with polarized light and fluorescence optical microscopy, mercury intrusion porosimetry, and ion chromatography analyses, were carried out to perform petrophysical characterization of stone samples and determination of soluble salts. Results show that the differential stone weathering is caused by small variations in the petrographic characteristics of the construction's geomaterials, such as the type and degree of cementation, porous network configuration, and presence or abse

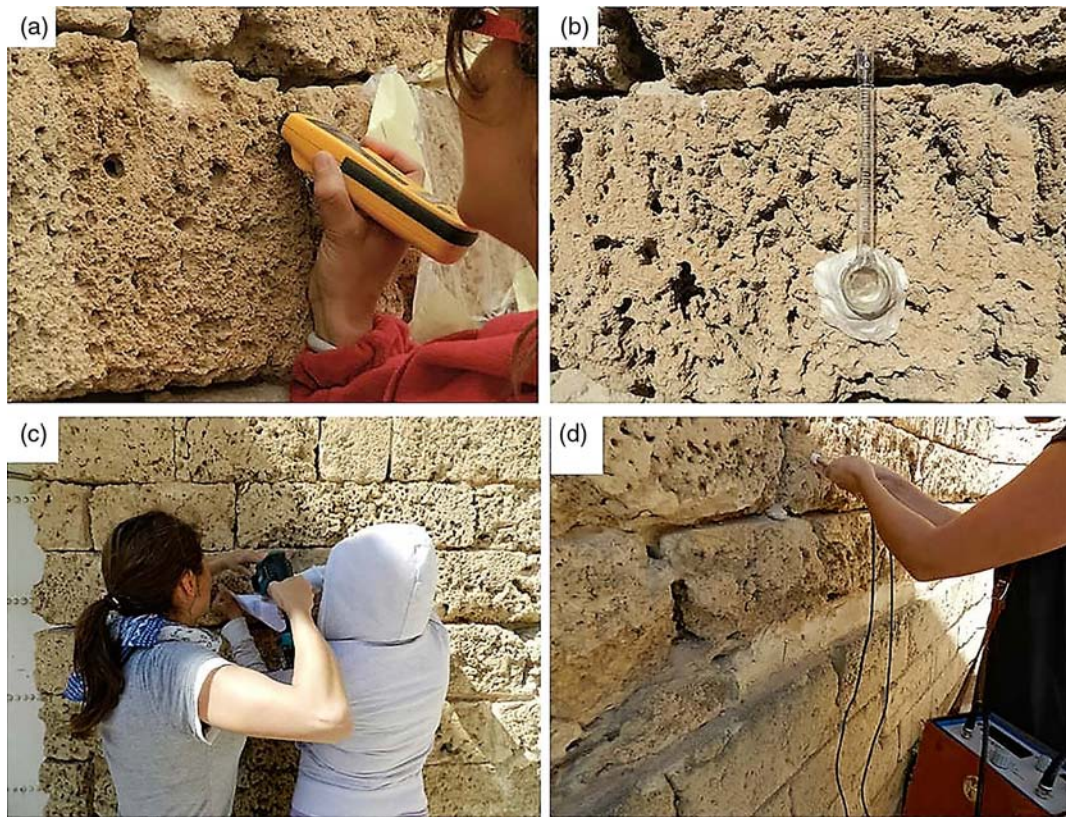
**Fig. 3.** On-site measurements with nondestructive techniques: (a) measurements of moisture content; (b) water absorption measurements by Karsten pipe; (c) sampling of stone powder by means of an electrical drill to perform further soluble salt measurements by ion chromatography analyses; (d) ultrasonic velocity ( $V_p$ ) measurements

Moisture content on the stone surfaces was measured with a portable moisture meter (GE Protimeter Surveymaster, Survey Express Services, London, U.K.) by penetrating pins (resistance sensor).

The nominal depth of the measurement was 19 mm (3/4 in.), although this depended on the density and other characteristics of the material. Depending upon the moisture reading, one of the LEDs will light up to allow the surveyor to read the moisture reading. When reading the damp measurement using the two pin mode (measure), the scale runs from 7 to 99% wood moisture content (WMC). The %WMC has become an industrially recognized reading for moisture whether the material is wood, brick, stone, or concrete. When reading the damp measurement using the search mode, the scale runs from 0 to 999 WME [Fig. 3(a)]. Depending on the dimension on the ashlar, from 8 to 16 measurements were performed (Fig. 4). The obtained results were processed with *Surfer* software to obtain moisture distribution maps of the studied rock ashlar.

NDT measurements were performed on selected stone ashlars by drilling with an electric drill at different depths (1, 3, and 5 cm from the surface) [Fig. 3(c)]. Only one test per lithotype was carried out and the stone ashlars were drilled in the center to avoid as much as possible the influence of the bedding mortar surrounding the ashlars. At each depth the stone powder generated by drilling was extracted and then the collected samples were analyzed by ion chromatography (IC) to quantify the type and concentration of soluble salts (ions) present in the drilled materials. Anions ( $\text{Cl}^-$ ,  $\text{NO}_3^-$ ,  $\text{SO}_4^{2-}$ ,  $\text{F}^-$ , nitrites, and oxalates) were determined in all the samples. Anion concentrations served to study the concentration of soluble salts with stone depth. The method used for extracting soluble salts was based on an alternative to the method described in the NORMAL standard with some additional modifications (Iñigo et al. 2001). Approximately 0.1 g of powdered stone samples was dissolved in 10 mL of Milli-Q ultra-pure water and placed for 45 min in an ultrasonic bath at ambient

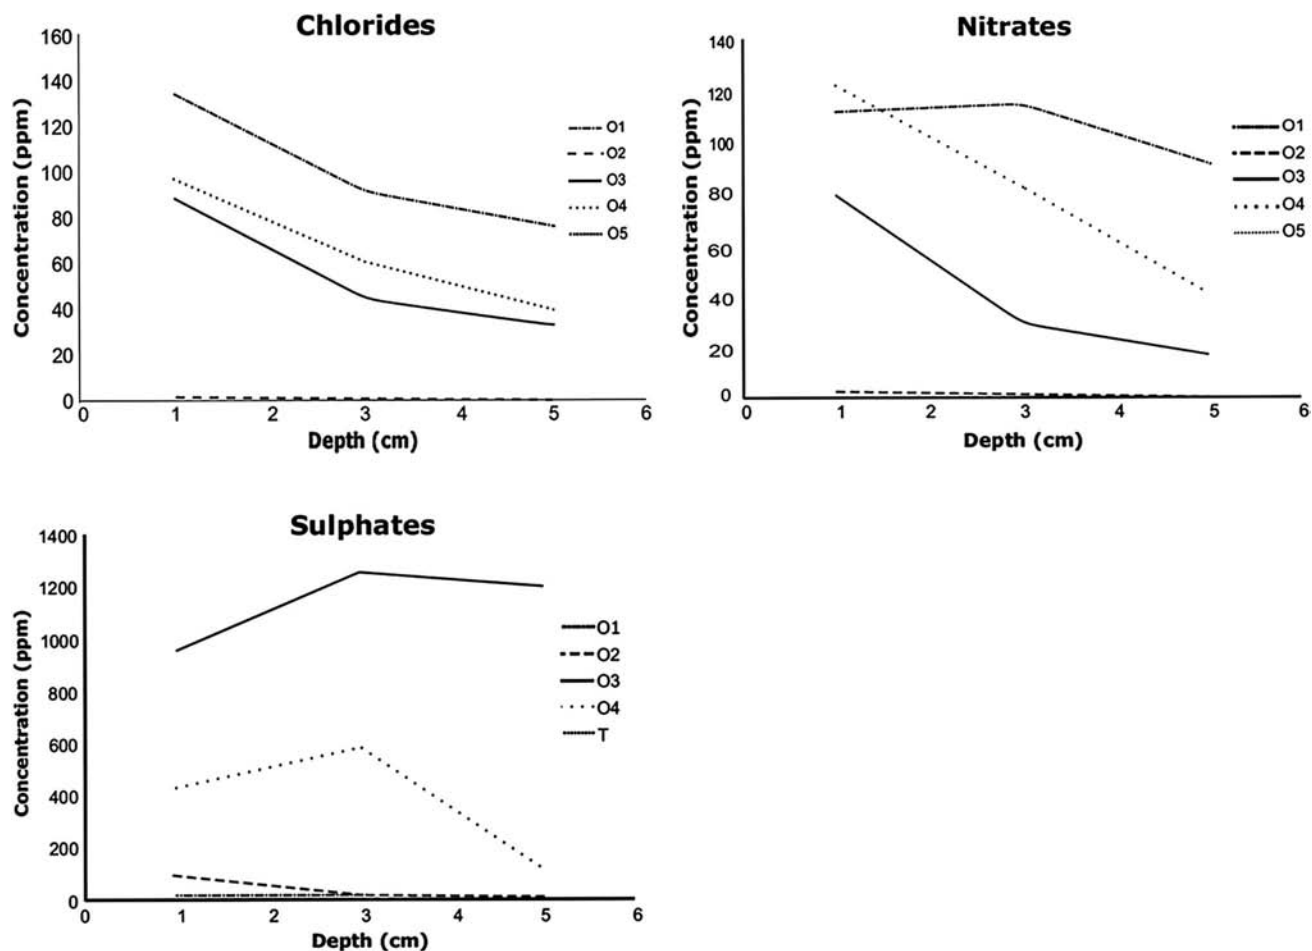
**Fig. 9.** Soluble salt content obtained by ion chromatography analyses from drilled samples collected at different depths from the surface of the stone ashlars

Fig. 9 shows the graphs with the anion salts content (chlorides, nitrates, and sulphates) obtained in the stone ashlar. In all cases a decrease in depth of the amount of salts can be observed, which indicates that the salts are mostly concentrated at the surface of the ashlar.
